## Architectural Heritage Impact Assessment

### Phase 2 Planning Amendment Saint Kevin's Hospital Site, Shanakiel, Cork City

**February 2024**

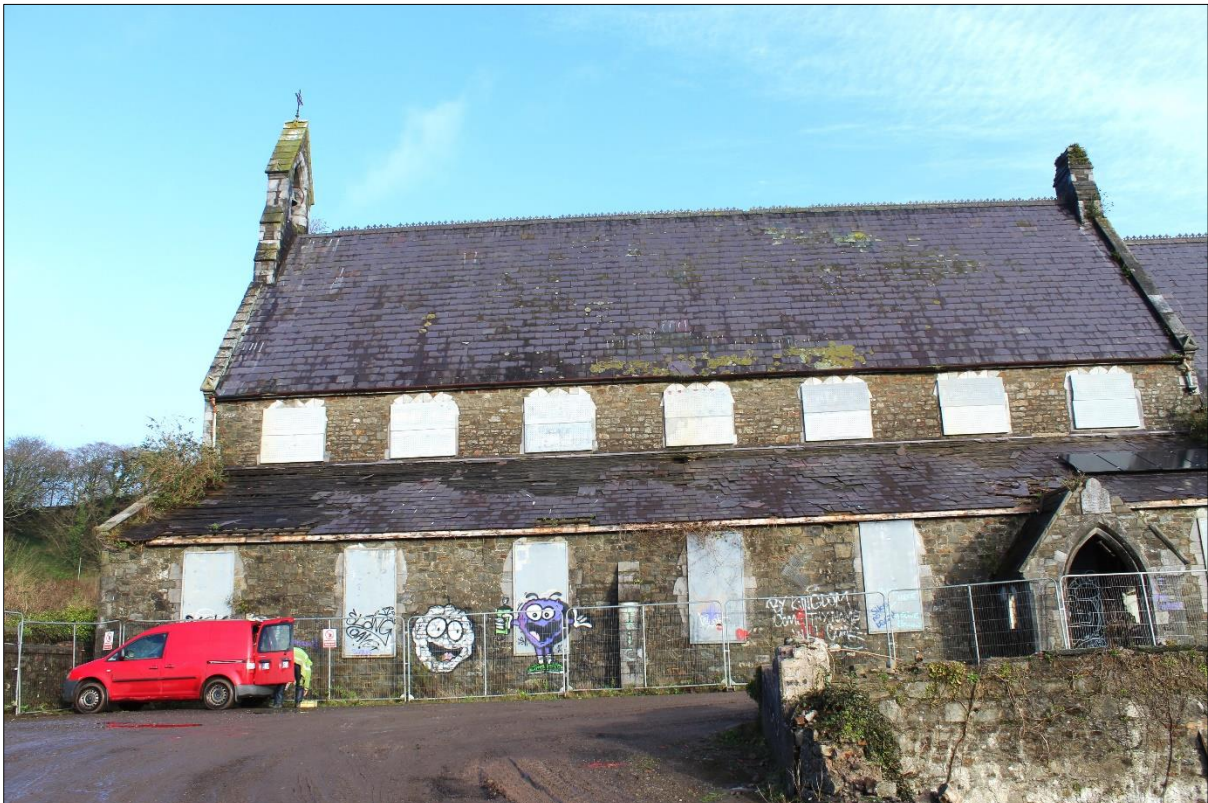
*Plate 2: Southern elevation with large area of missing slates to western side of aisle roof*

- repairs to the existing timber roof structure and reinstatement of salvaged slate cladding,
- raking out cement mortar joints to all external stonework and re-pointing with appropriate lime mortar,
- replacement of missing cut limestone details including several gable parapet cap stones,
- repair and matching replacement of broken sections of cast-iron rainwater goods,
- repair and/or appropriate replacement of damaged window frames,
- replacement timber doors,
- perimeter drainage of ground and storm gullies,
- stripping of damaged internal wall plaster and replacement with suitable lime plaster,
- repairs and/or replacement of existing historic joinery to balcony and stairs,
- repair and refurbishment of masonry boundary walls and wrought-iron railings around perimeter of building.

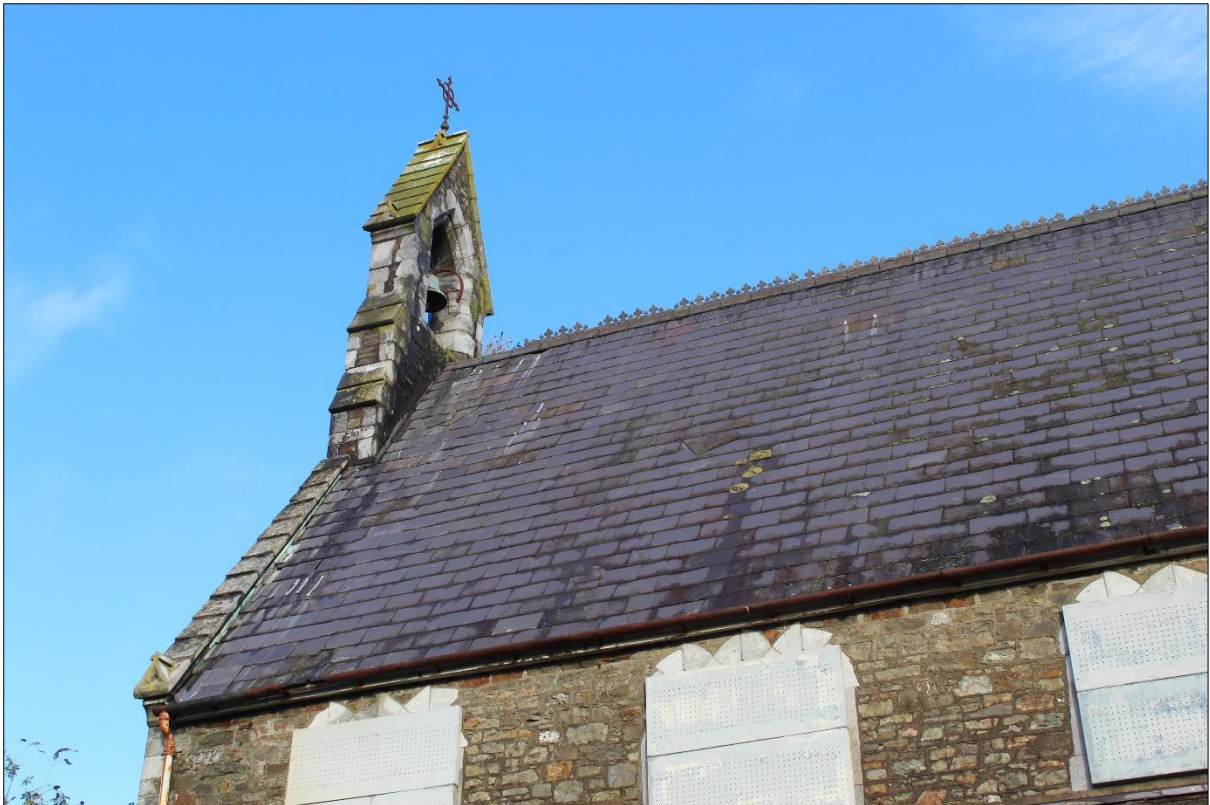
**Plate 3:** Detail of western bell-cote, localised loose slates and cement-pointed, weathered masonry of southern clerstorey.

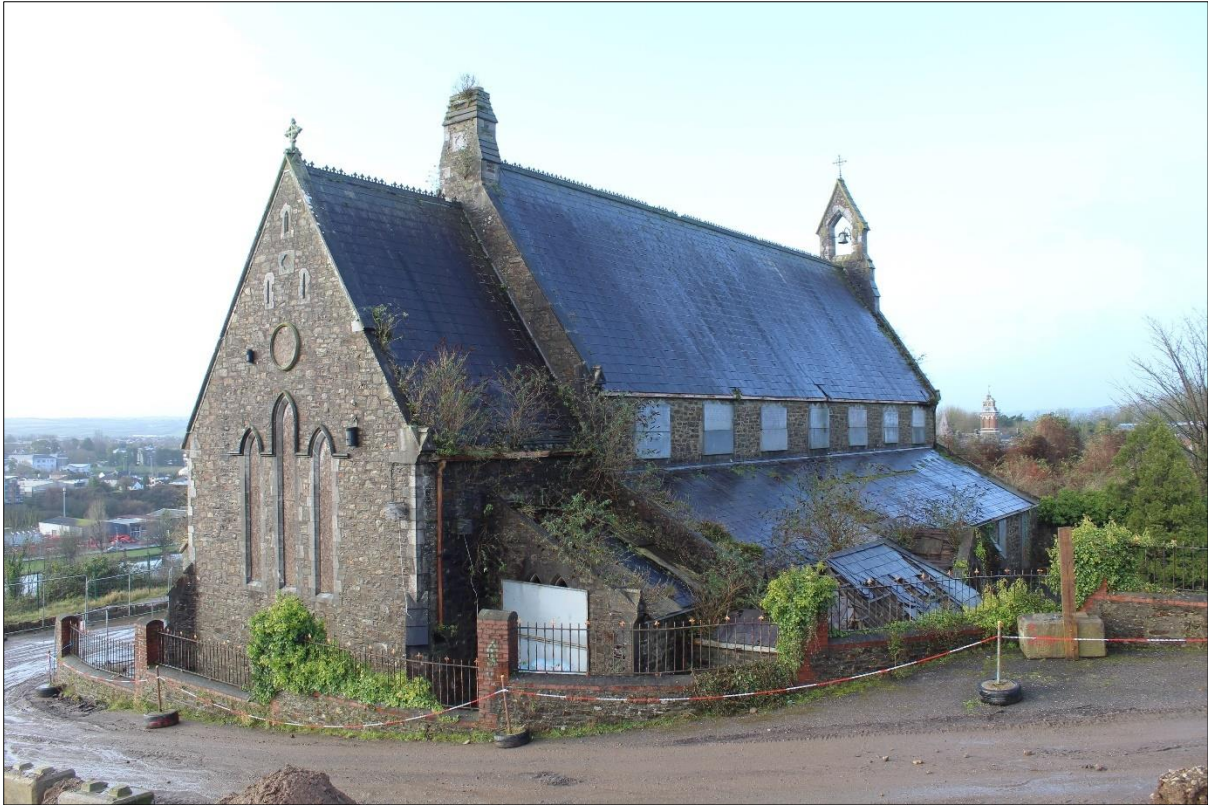
**Plate 9:** East gables and northern elevation of former chapel with curved brick and rubble masonry retaining wall supporting higher ground levels around the building with wrought-iron railings protecting the parapet.

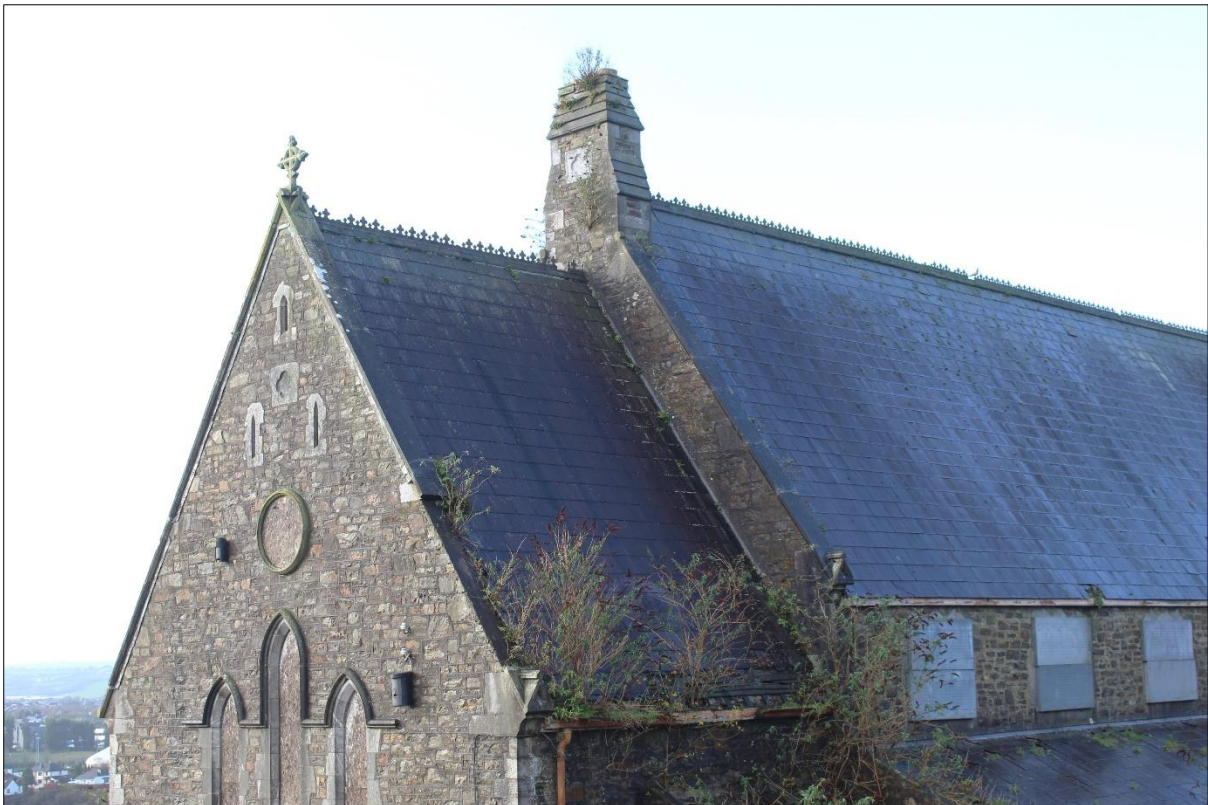
**Plate 10:** Detail of east gable masonry, chimney over chancel arch and damaging vegetation growth to exposed wall-tops on north elevation and lower portion of east gable wall of sanctuary

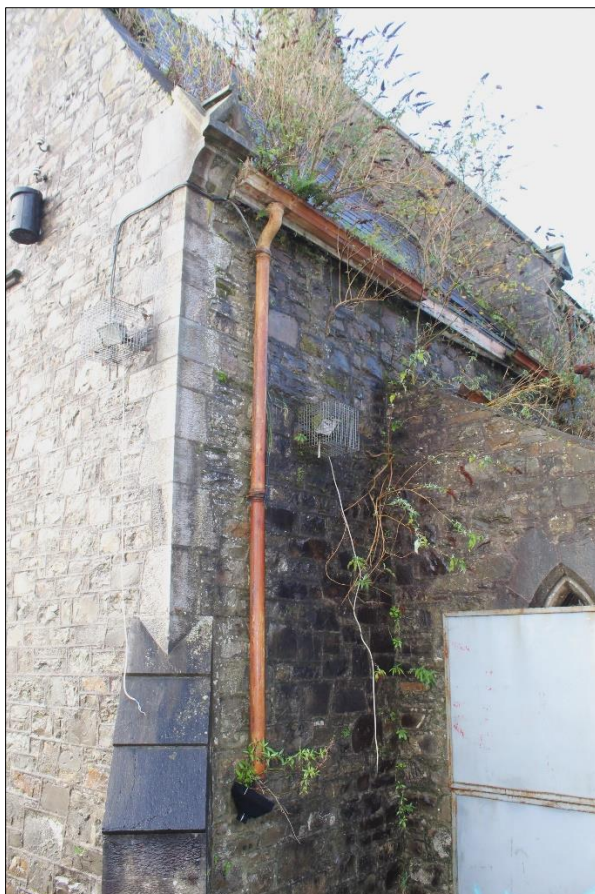
*Plate 11: Detail of masonry at north-east corner of sanctuary with remnants of replacement cast-iron rainwater goods.*

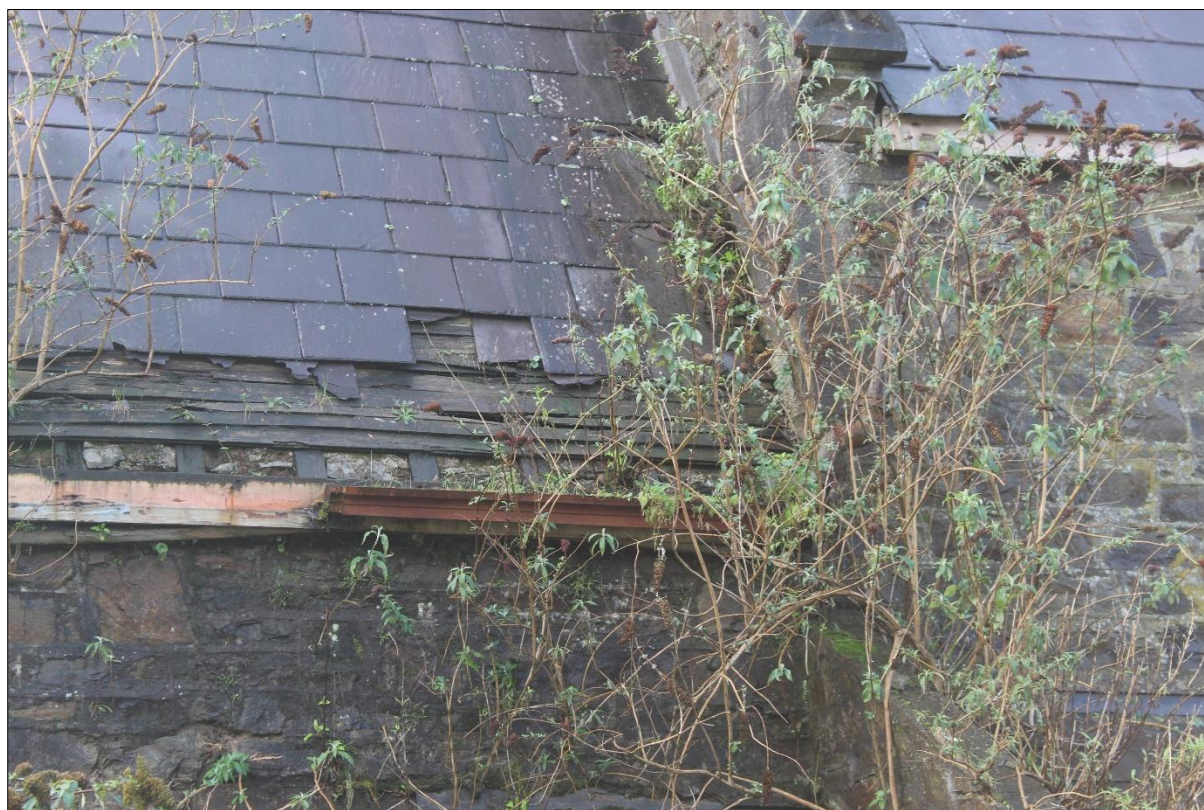
*Plate 12: Detail of exposed wall-tops and partially sarked rafter ends to northern elevation of sanctuary*

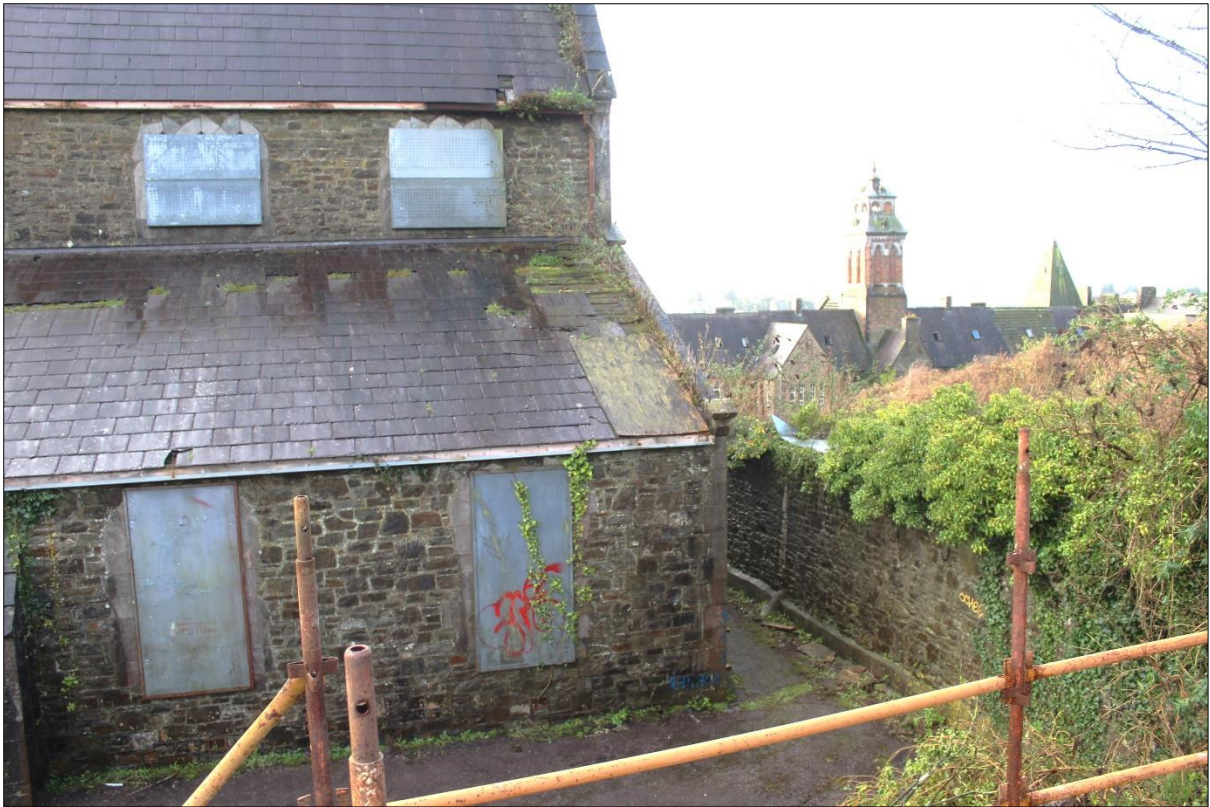
*Plate 17: Area of missing slates at west end of northern aisle*

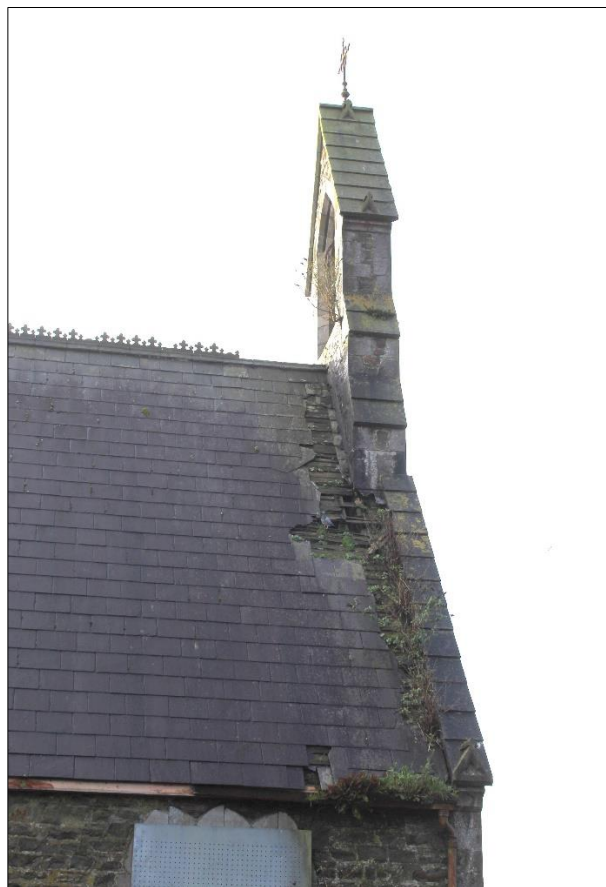
*Plate 18: Area of missing slates at west end of main nave roof on northern elevation*

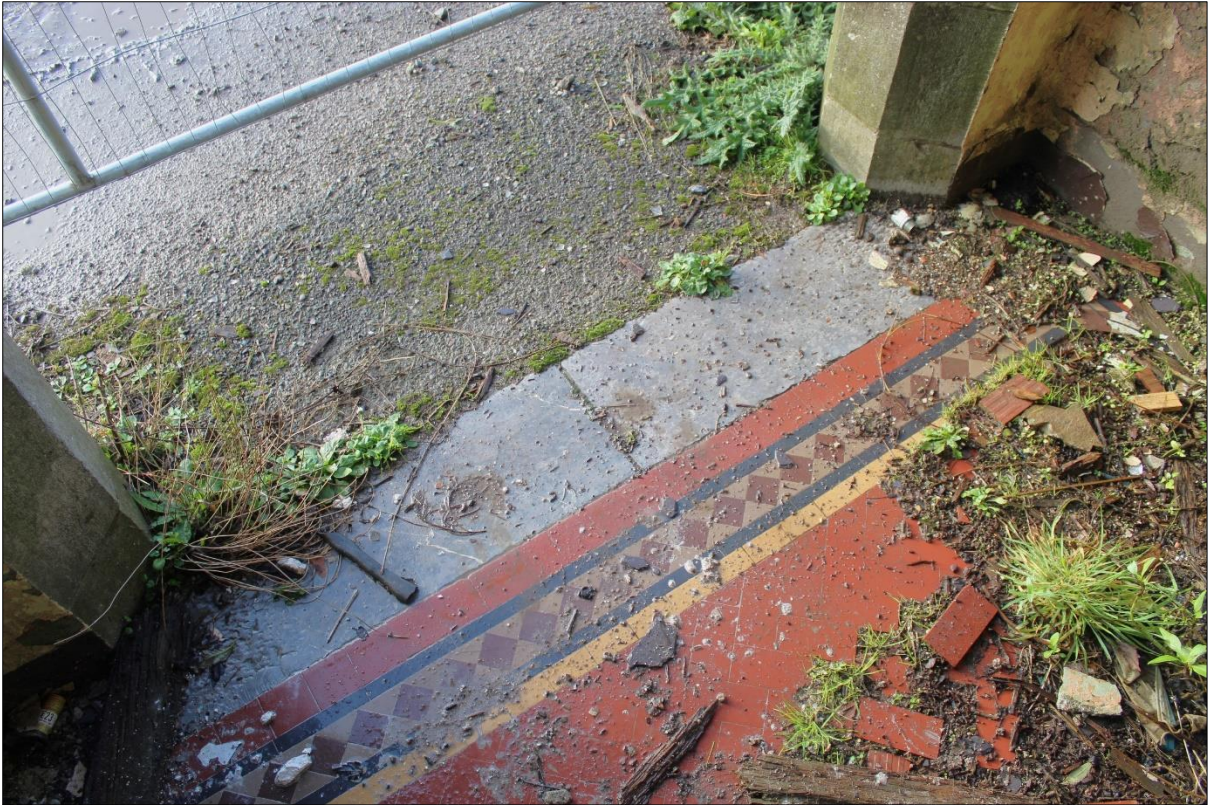
*Plate 19: Detail of geometric clay tiles and cut limestone threshold to main, southern entrance porch interior*

the building which will remain legible in the redesigned interior. Incorporation of salvaged geometric floor tiles in an appropriate manner within the new creche facility will be a positive means of retaining historic fabric and some of the original character of the building in its reimagined form.

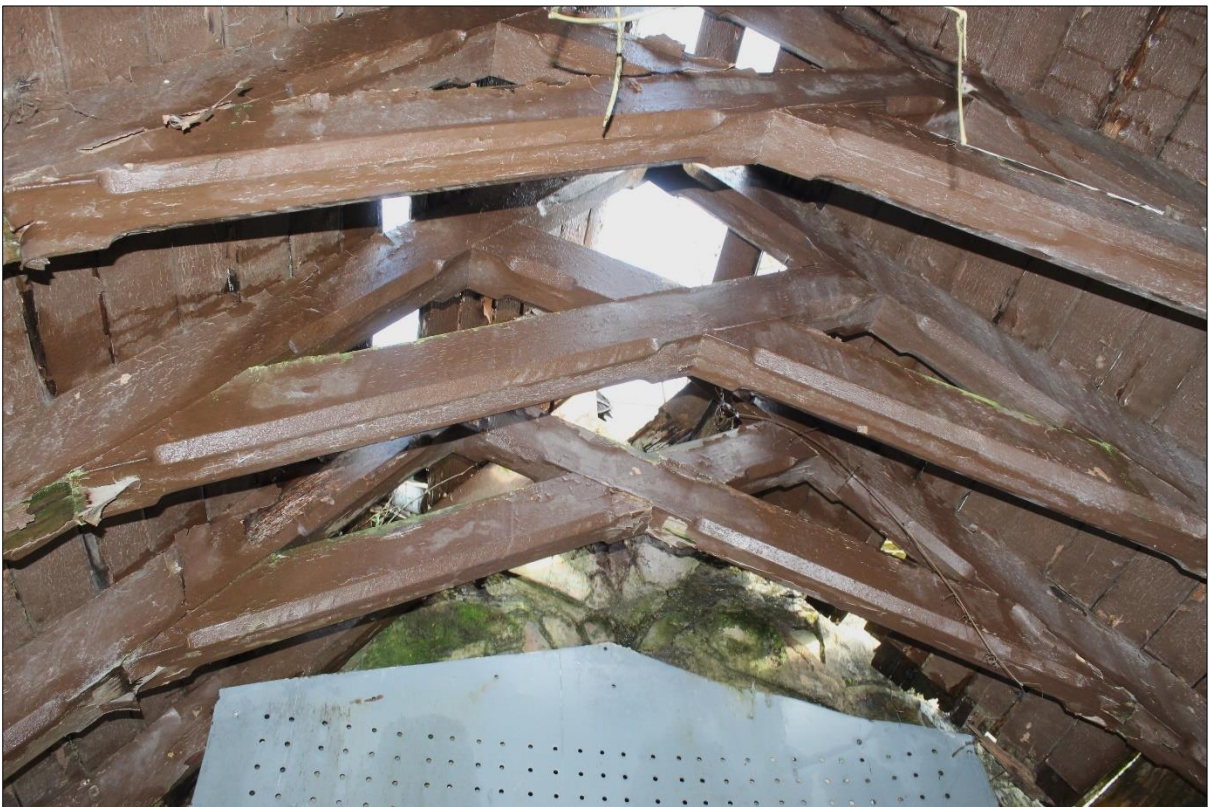
*Plate 20: Detail of exposed underside to chamfered timber structure of damaged, roof to southern entrance porch.*

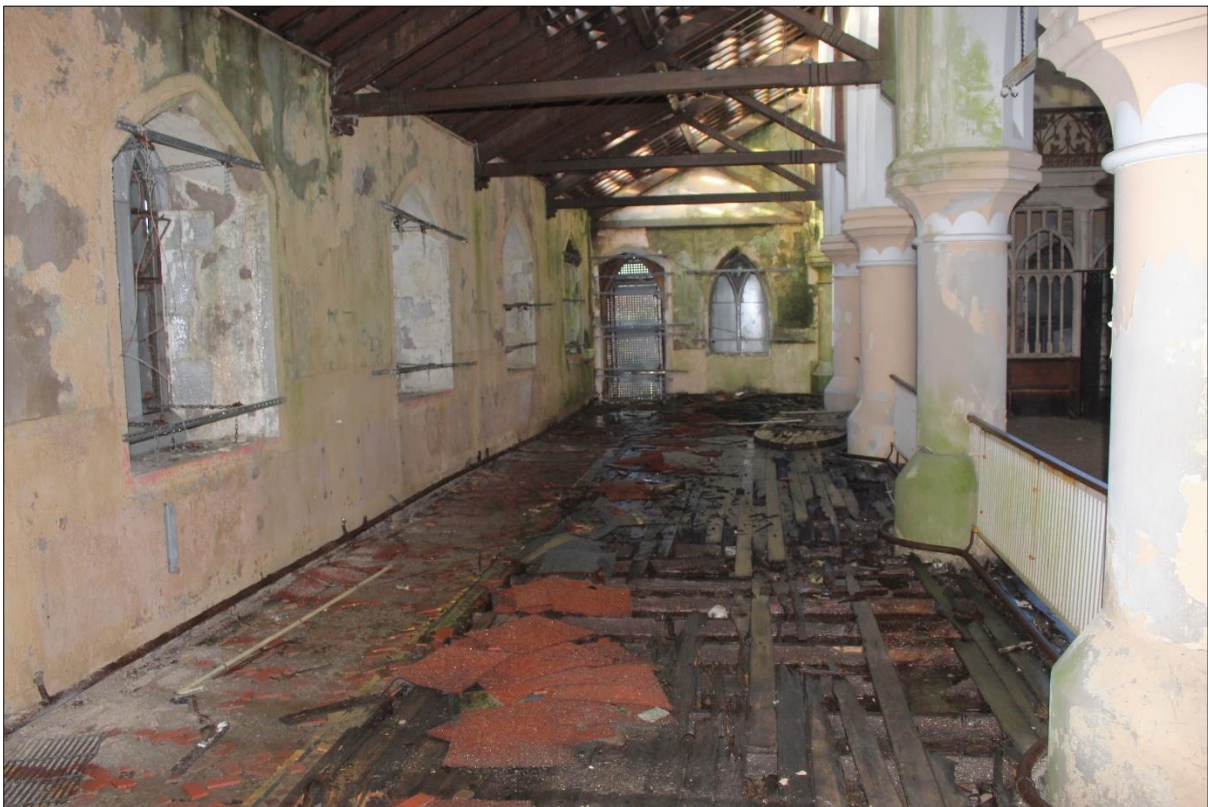
*Plate 22: View to west along southern aisle with decayed timber floor that formerly held pews and geometric clay-tiled path along wall.*

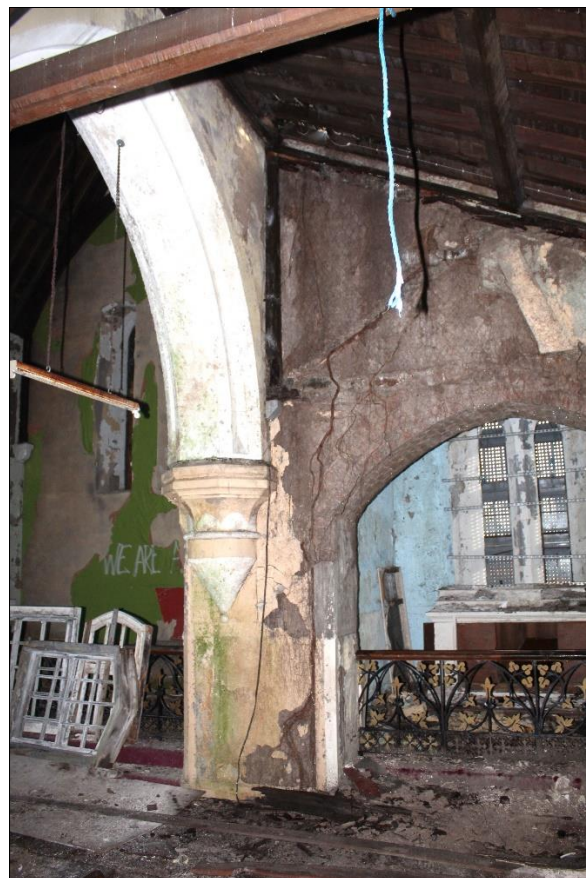
*Plate 24: Severe moisture ingress at junction of wall separating southern aisle from southern side altar and south wall of nave with damaging vegetation exacerbating decay of plaster surface and masonry.*

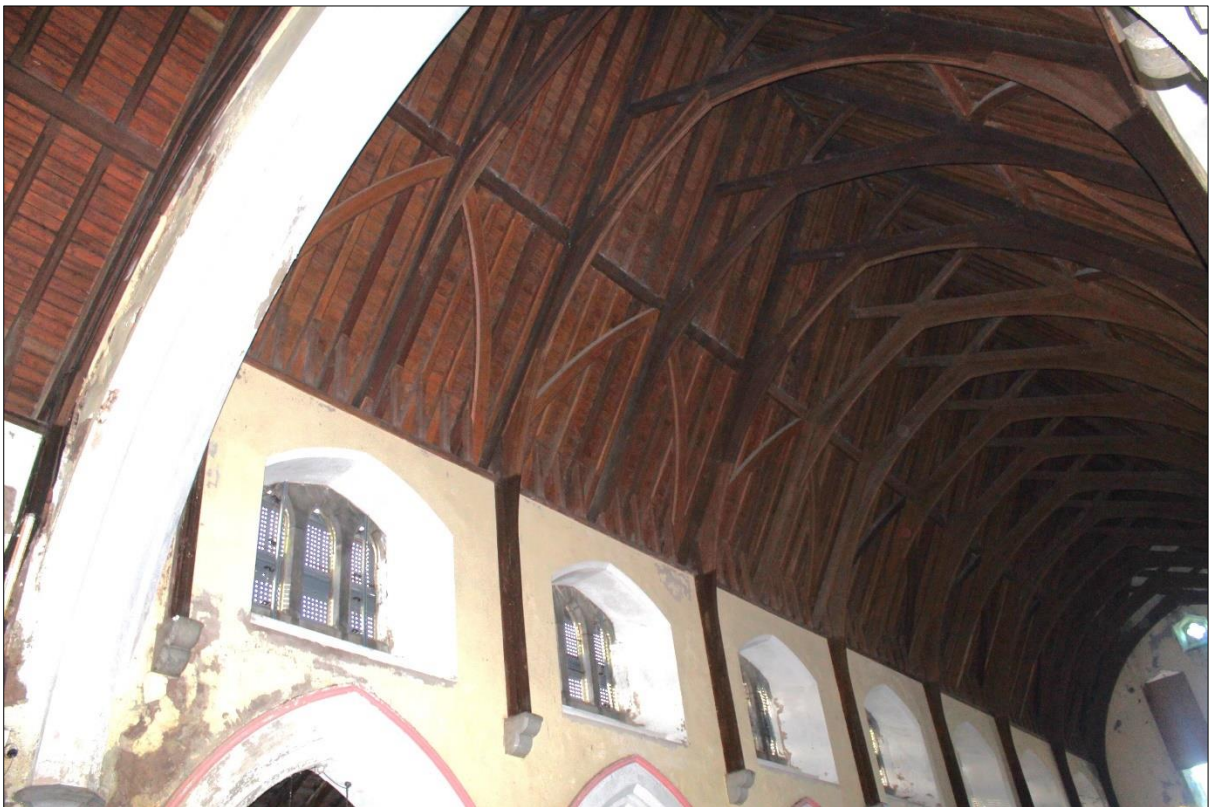
*Plate 26: Detail of scissor-truss roof and southern clearstorey from beneath chancel arch.*

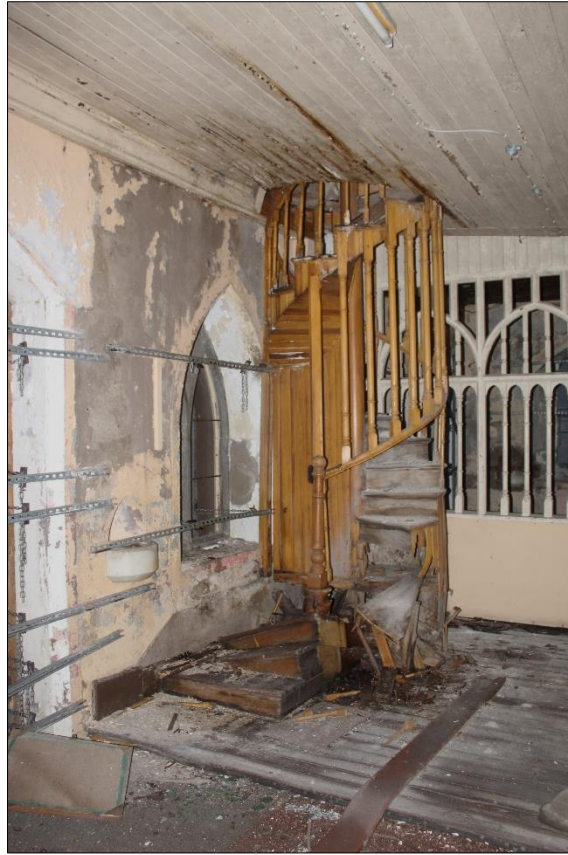
*Plate 29: Badly-decayed timber spiral staircase to west balcony*

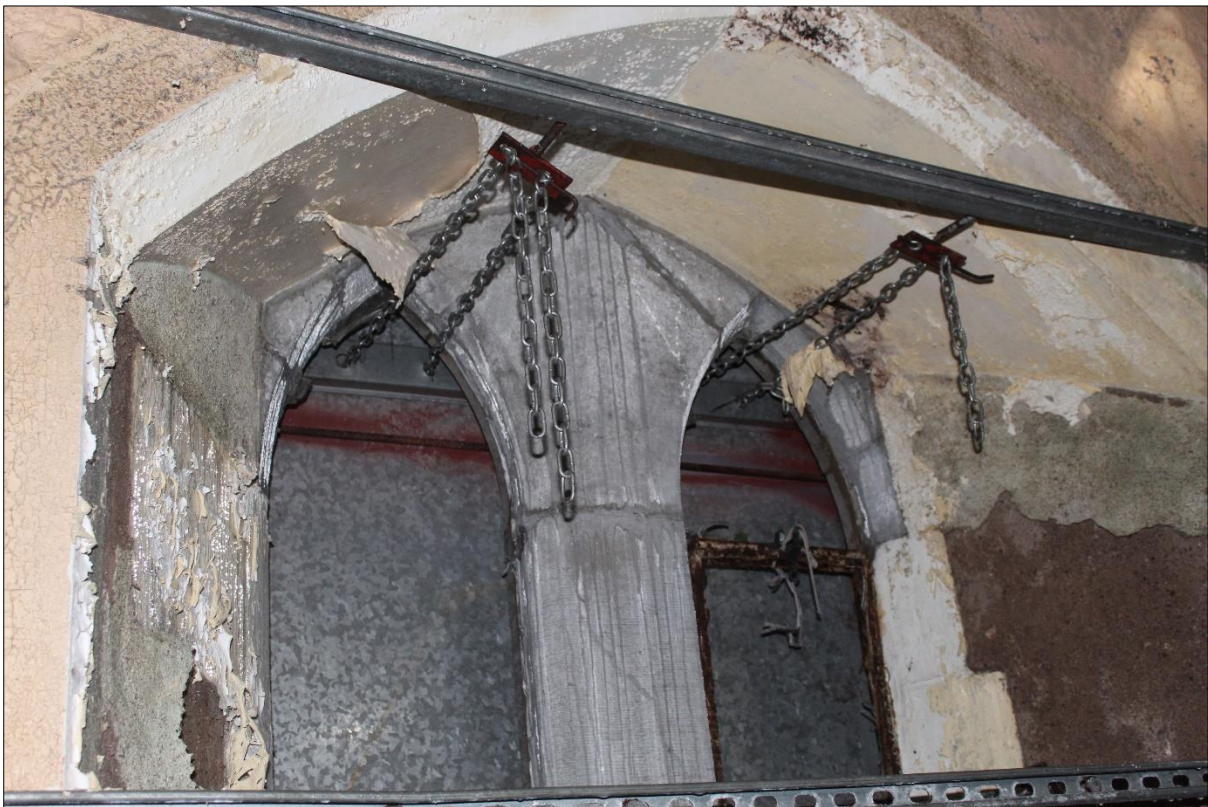
*Plate 32: Detail of cut limestone frame to cast-iron windows on northern aisle*

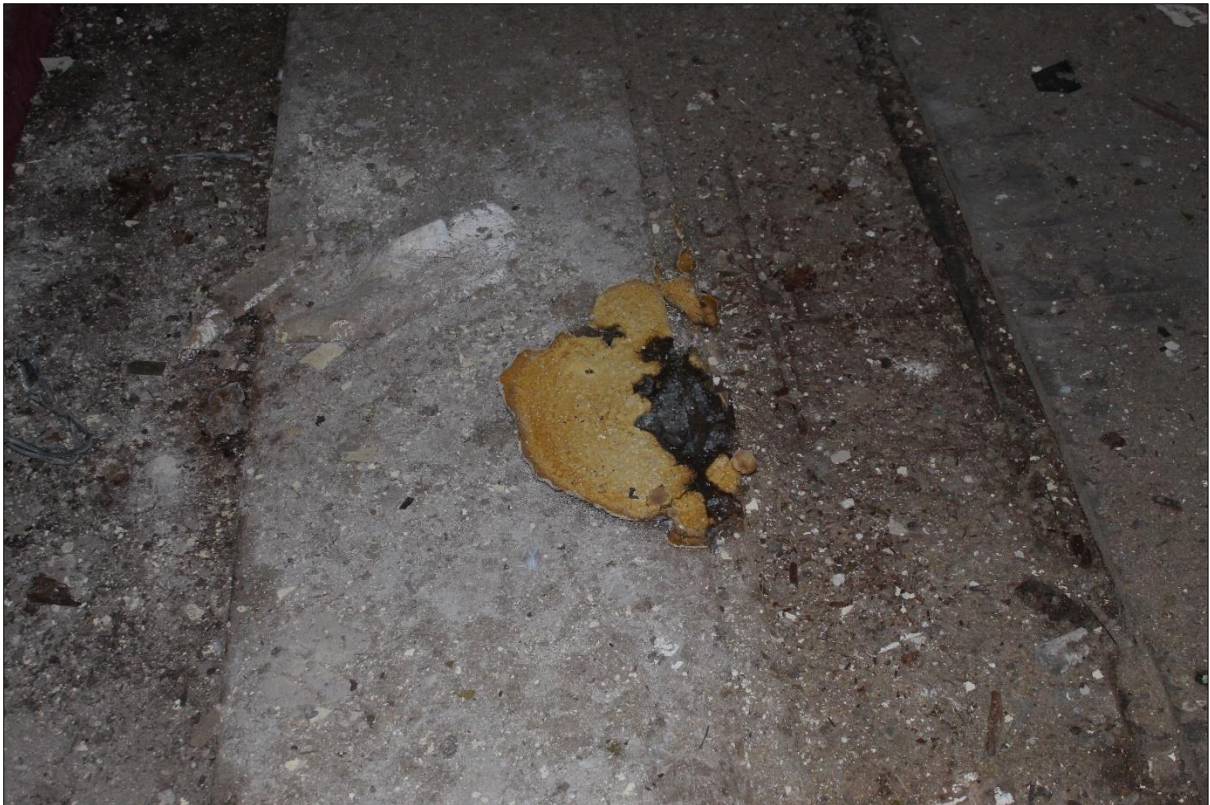
*Plate 33: Significant fruiting body of timber decay fungus on floor adjacent to main alter step. Initial phase of assessment of building by timber decay specialist has identified extensive, severe infestation as a result of prolonged water ingress.*

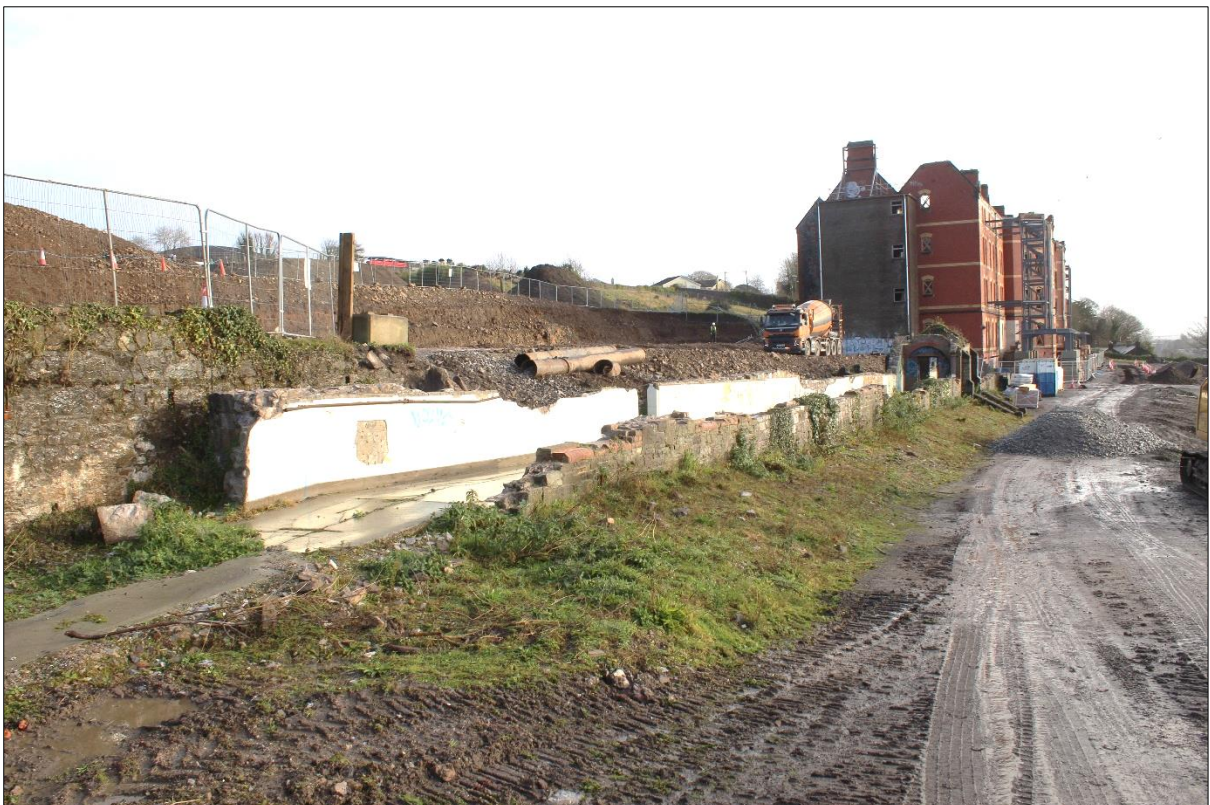
*Plate 34: View to east along remains of link corridor towards former Saint Kevin's Asylum building which has been stabilised for development in phase 2 of the overall construction project.*
